**LAKE SAINTE LOUISE DAM
ST. CHARLES COUNTY, MISSOURI
MO 10490**

PHASE 1 INSPECTION REPORT NATIONAL DAM SAFETY PROGRAM

Name of Dam: Lake Sainte Louise Dam
State Located: Missouri
County Located: St. Charles
Stream: Tributary of Peruque Creek at Lake Saint Louis
Date of Inspection: 19 June 1978

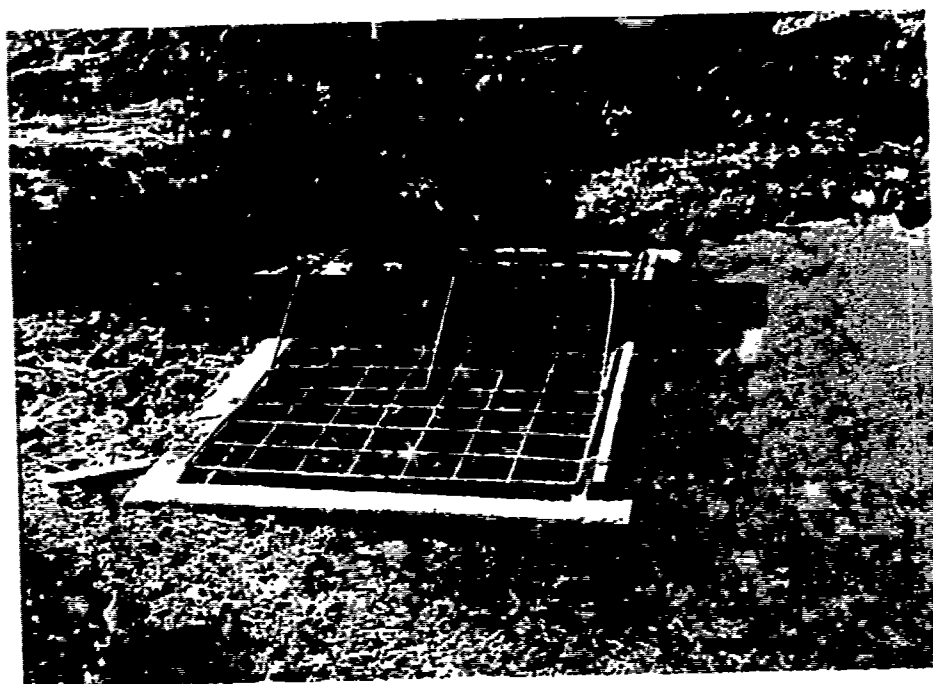
NO. 3: 48"x102" DROP INLET SPILLWAY

d. 48-Inch by 102-Inch Rectangular Spillway. The 48-inch by 102-inch drop inlet type spillway (see Photo 3) located at the east end of the dam appeared to be in good condition. The 2-foot high section of stop-log planks on the lake side of the inlet were leaking a negligible amount. An anti-vortex plate and a screen to prevent trash from entering the inlet had been installed above the open top of the inlet. Both the plate and screen appeared to be in good condition. A 36-inch diameter corrugated metal pipe serves as an outlet for this inlet. The 36-inch pipe appeared to be in good condition although the type of joints used could not be determined. The pipe discharges into an open concrete manhole (see Photo 4) located approximately 150 feet from the centerline of the dam near the right abutment. A 15-inch diameter pipe extends approximately 28 feet from the manhole and terminates at an unimproved ditch (see Photo 5). An accumulation of construction debris was observed at the upstream end of the ditch. The ditch continues for about 420 feet before it joins Lake Saint Louis (see Photo 6). The ditch at the upstream and downstream (Lake Saint Louis) ends was extensively eroded, apparently by flow being discharged from the 36-inch diameter outlet pipe.

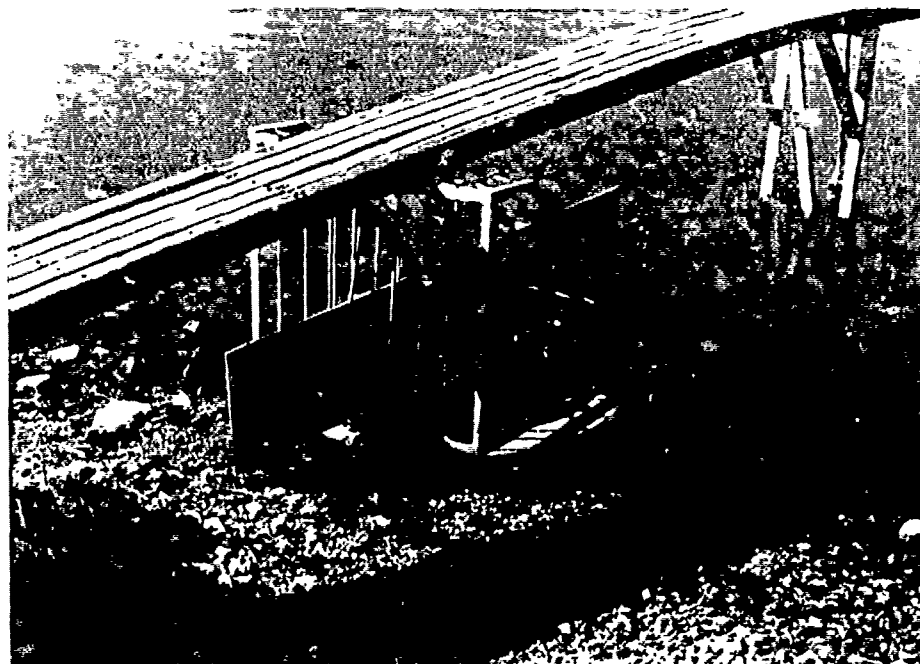
No. 7: 42" DIAMETER DROP INLET SPILLWAY

Modifications by the owner to the outlet pipe of the 42-inch drop inlet spillway located near the center of the dam for installation of a lake replenishment pump have negated the use of the pipe as a spillway. These changes include plugging the existing 12-inch pipe outlet with concrete such that it no longer functions as an outlet, and installation of a 10-inch valve and pipe to connect the existing 12-inch outlet pipe to a pump discharge line. The valve is normally maintained closed in order to prevent backflow and loss of water from the lake. When the pump is installed (it was not at the time of the inspection) and operated, the valve is opened and flow is introduced into the lake through the 42-inch vertical riser. At the time of the inspection the valve was closed, although it was leaking at the rate of several gallons per minute.

c. 42-Inch Diameter Spillway. The 42-inch diameter drop inlet type spillway (see Photo 7) located near the center of the dam appeared to be in good condition although it did have an accumulation of small stones and/or debris lying in the bottom of the inlet. An anti-vortex baffle plate and a screen to prevent trash from entering the inlet had been installed above the open top of the inlet. Both the plate and screen appeared to be in good condition. The operating stem for the gate on a pipe line located out in the

lake and leading to the inlet was disconnected and not operable. Water was standing in the inlet to the same level as the lake. The outlet pipe for this spillway had been modified as indicated in the preceeding paragraph. The condition of this pipe could not be determined since only the top of the pipe at one location (near the 10-inch valve) could be seen.

(4) Restore the 42-inch spillway to its original condition by closing the valve on the lake inlet pipe and unblocking the outlet pipe. This will allow the spillway to function as originally intended (as long as the valve on the pump connecting line is closed or the line blocked) and will eliminate the condition of having the 12-inch outlet pipe under permanent head. The purpose of this recommendation is to eliminate a condition considered undesirable under any circumstances and will not increase spillway capacity as recommended in paragraph 7.2a(1). It will, however, improve the reliability of this spillway since it will not be necessary to open the valve on the pump connecting line in order to allow the outlet pipe to be serviceable.

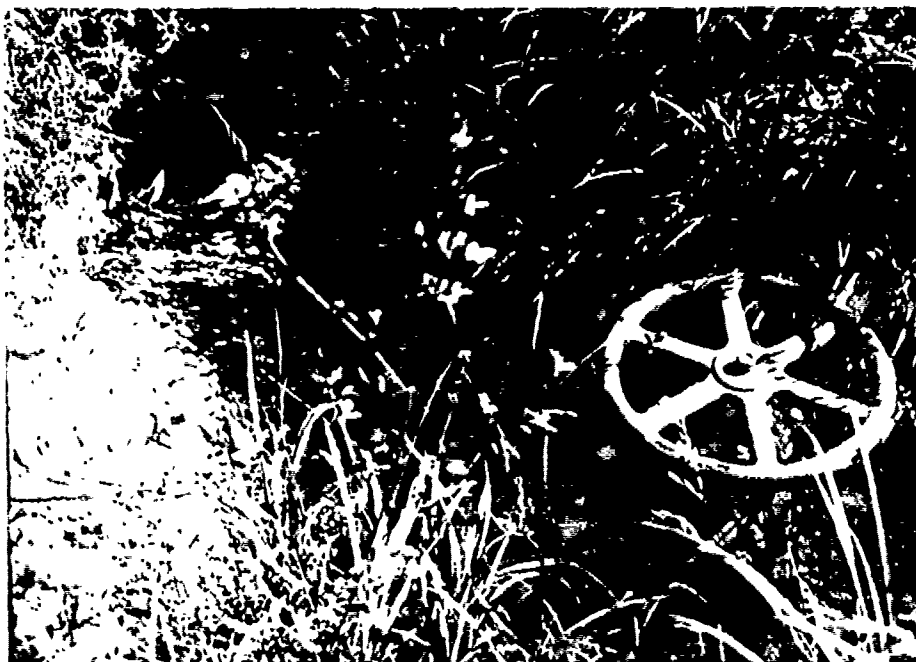
NO. 9: 10" VALVE ON PUMP DISCHARGE LINE

outlet pipe for the 48-inch by 102-inch spillway is unimproved and not maintained. The valve on the 10-inch pump discharge line of the modified outlet pipe for the 42-inch spillway is, according to the Director, in operating condition although it leaks moderately when in the closed position.

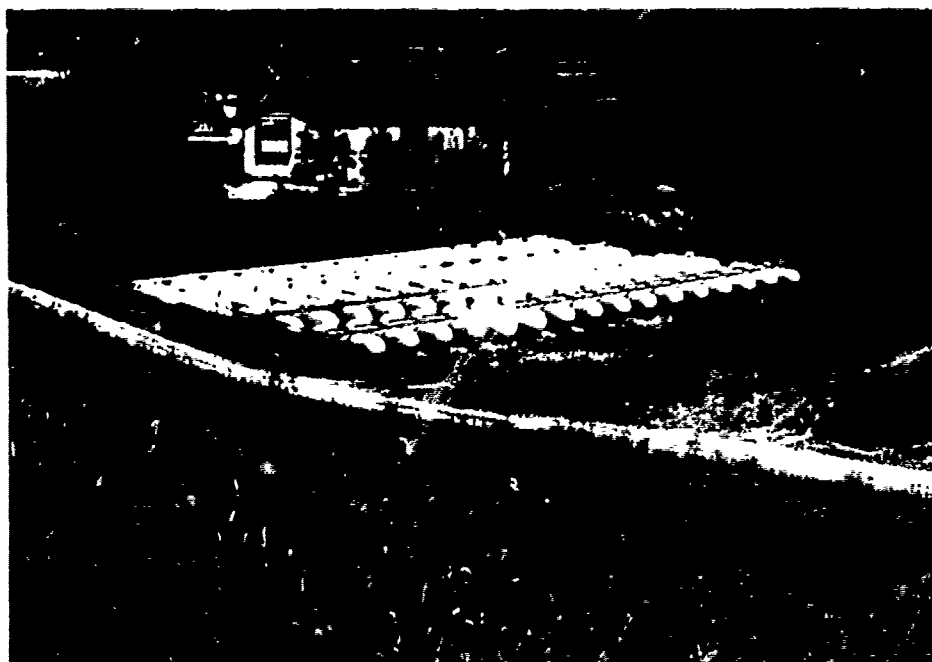
NO. 12: LP TANK FARM

It is believed that the liquid petroleum tanks located on the area adjacent to the downstream toe of slope of the dam presents a hazardous condition should failure of the dam occur. In addition to damages due to the flood wave if the dam fails, the leakage of liquid petroleum will create a possible explosion hazard.

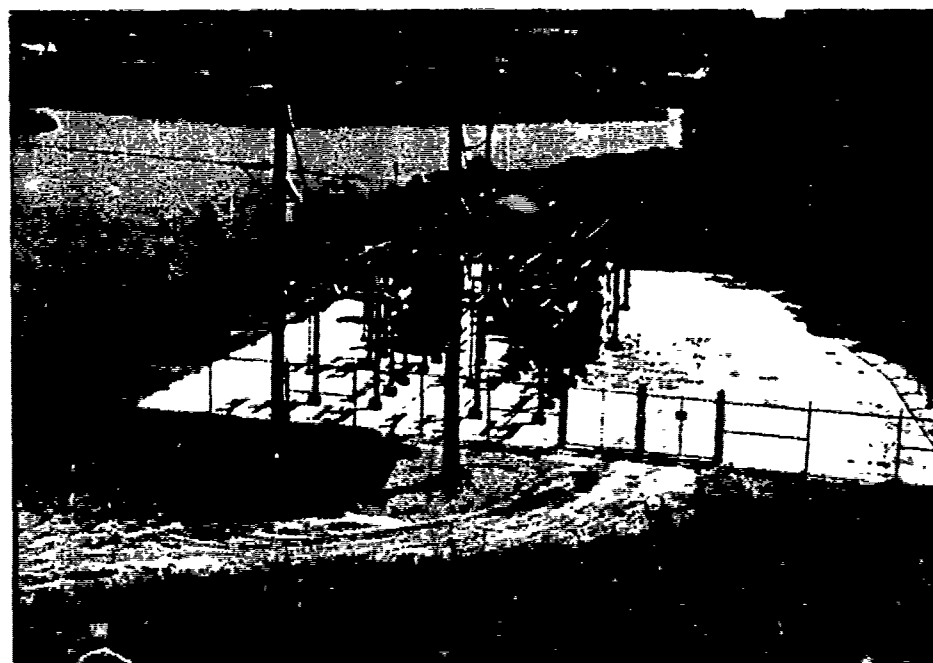
NO. 13: ELECTRIC SUBSTATION

Also present on the downstream area immediately adjacent to the dam is an electric substation. Failure of the dam would undoubtedly damage or destroy this installation. Explosions caused by sparks igniting leaking LP gas may cause damages above the level of the floodwaters.
